DEFORMATION ESTIMATION OF THE ROMAINE-2 DAM FROM MULTIBEAM ECHO SOUNDER SURVEY DATA

Mathieu Rondeau, CIDCO, Rimouski, QC, Canada
Nicolas Seube, CIDCO, Rimouski, QC, Canada
Camille Stoeffler, CIDCO, Rimouski, QC, Canada
Alain Côté, Hydro-Québec Research Institute, Varennes, QC, Canada
Alain Croteau, Hydro-Québec Research Institute, Varennes, QC, Canada

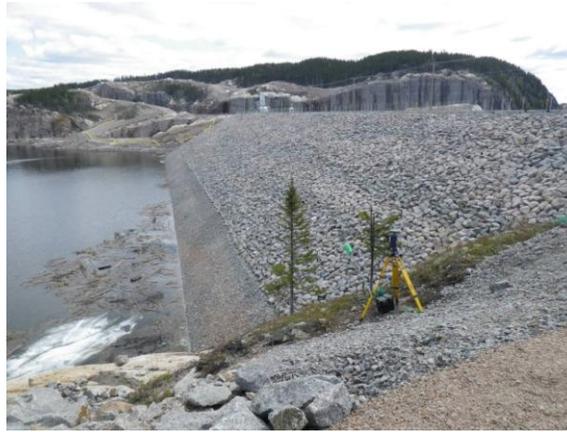
Both MBES surveys were referenced with respect to a geodetic point established and monumented by Hydro-Québec's geomatics department, which is shown along with a side view of the half-filled dam (Figure 4).

Figure 4: Side view of the Romaine-2 dam at half loading. The GNSS base station is located on the geodetic control point

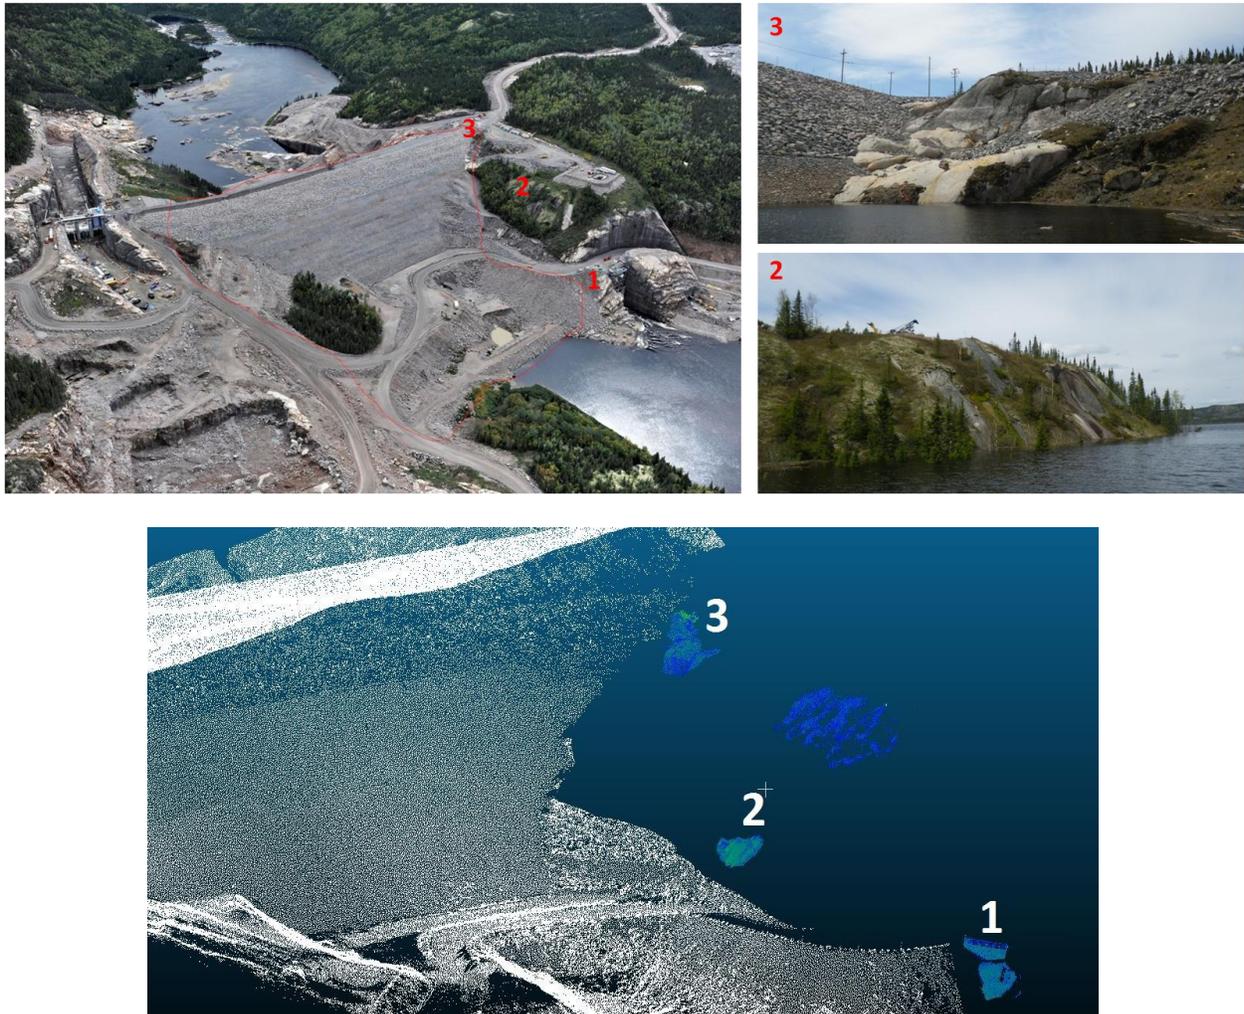
For the purpose of quality assurance, Hydro-Québec's geomatics department performed a 3D laser scanner survey of the empty dam, just before starting the filling phase. LiDAR reference data needs to be located on areas that are not subject to deformation after dam impoundment. Three areas from natural rock slopes were selected as shown in the Figure 8 below. Figure 9 is a detail of one of the reference areas.

Figure 8: Reference LiDAR surfaces as defined by Hydro-Québec

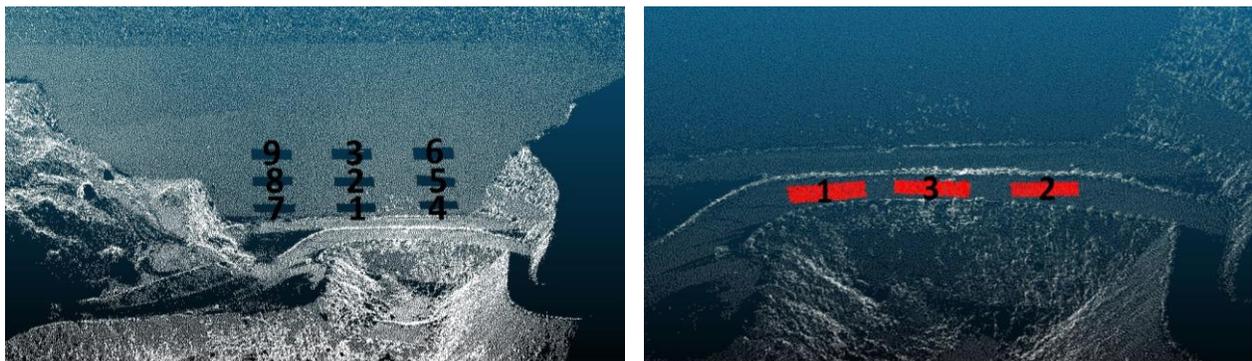
Survey data quality being assessed and validated, we can now study the dam deformation due to loading. As shown in Figure 11, two sets of surface patches have been selected in order to detect the presence of deformation of the dam:

- Nine surface patches located on the dam slope itself;
- Three patches located on the top of the cofferdam.

Figure 11: Surface patches locations for dam deformation analysis. Nine surface patches have been defined on the dam itself and three on the cofferdam.
